Roof Inspection Report

On October 15, 2012, the owners of a property in Atenas, Costa Rica asked me to conduct an inspection of the roof leaks they had been trying to repair for years. Their main residence and guest house both had water infiltrating into the interiors of the dwellings through gaps between the roof laminates and under the flashing materials.

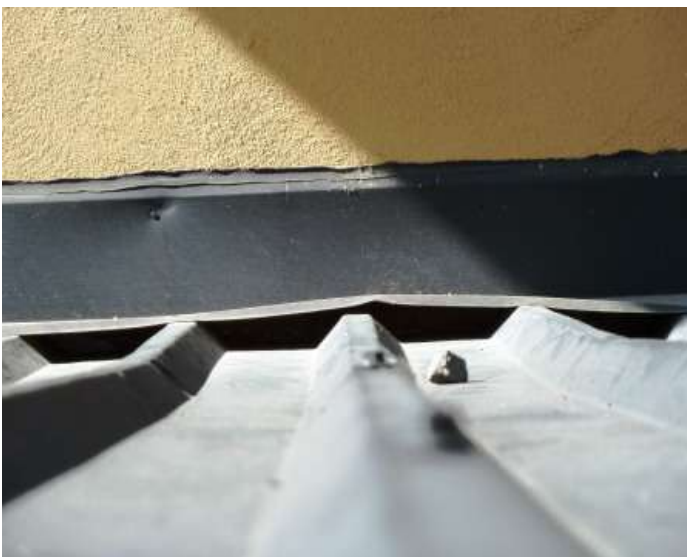
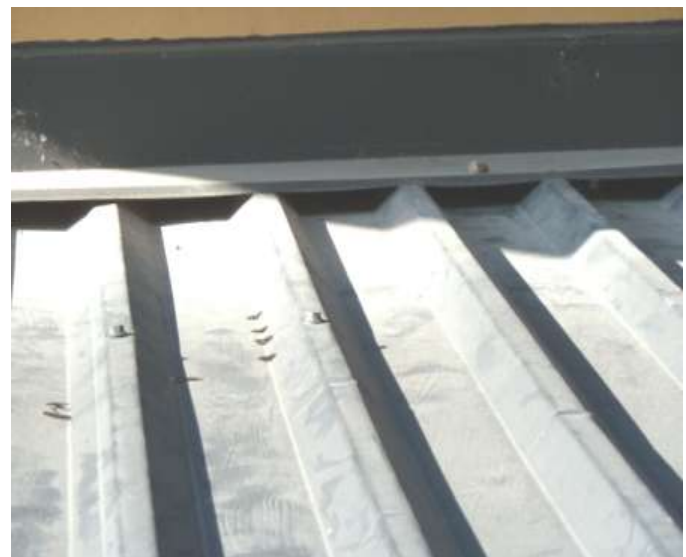
On both dwellings there are several types of flashing materials in various locations. The lower roofs have flashings installed where the roof surface meets the exterior vertical walls. Because of the nature of the corrugated metal laminates, there are gaps under the flat flashing materials where driving rain water enters underneath and filtrates below into the home. Additionally, the top of the flashing material is attached to the vertical wall with nails and a silicone type of sealant has been applied at the joint. This sealant dries out quickly in Costa Rica because we are less than 10 degrees from the equator and the ultraviolet radiation prematurely deteriorates most exterior construction materials. When the sealant dries out, it cracks and water can infiltrate in the cracks.

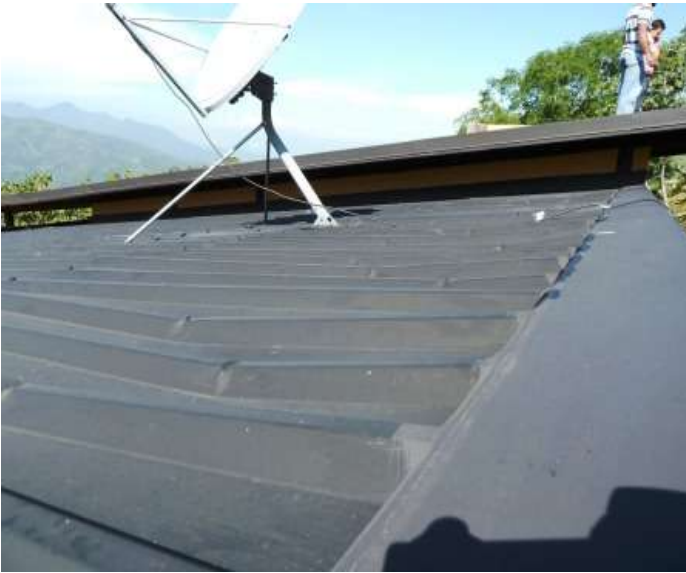
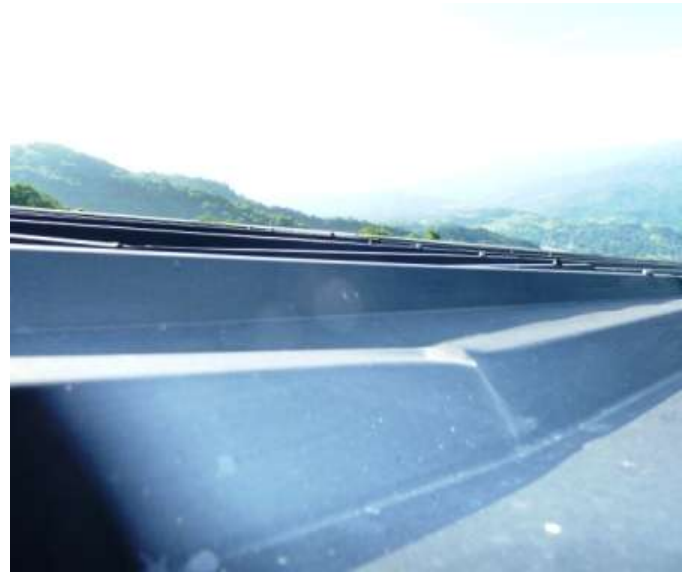
Both roofs have identical roofing laminates and some areas have been dented by workers walking on the roof in between the metal supports. Near the television antenna the dents are deeper and water accumulates in them and causes premature corrosion.

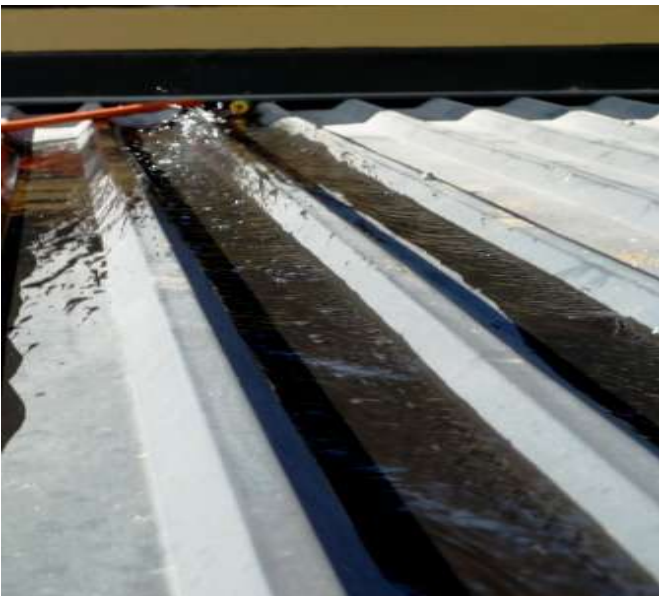
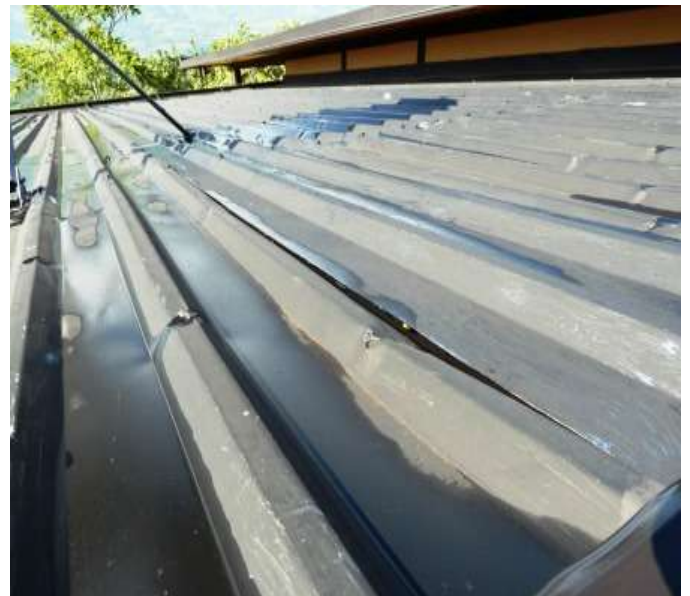
I conducted water tests on both roofs by bringing a garden hose up on the roof and first letting the water run down the roof laminates to determine if there was water infiltration occurring on the laminates. On the guest house there were no leaks on the laminates, but when I diverted the water pressure against the vertical walls and the flashing, the water leaked into the ceiling of room below.

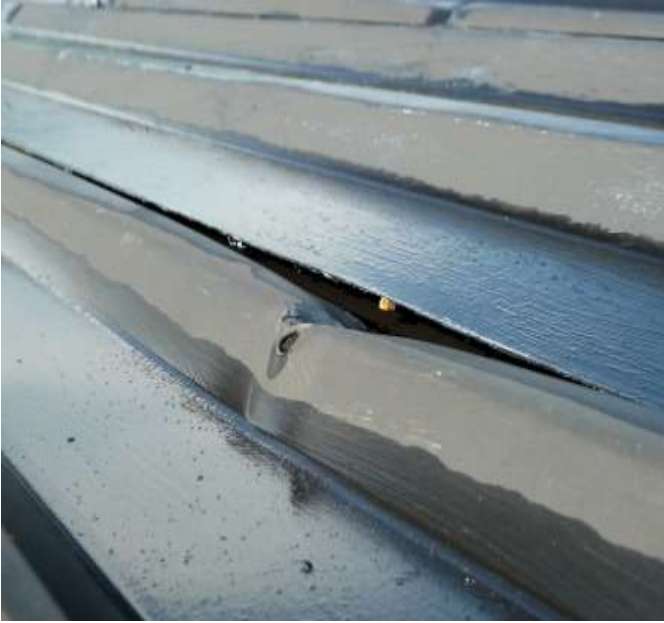
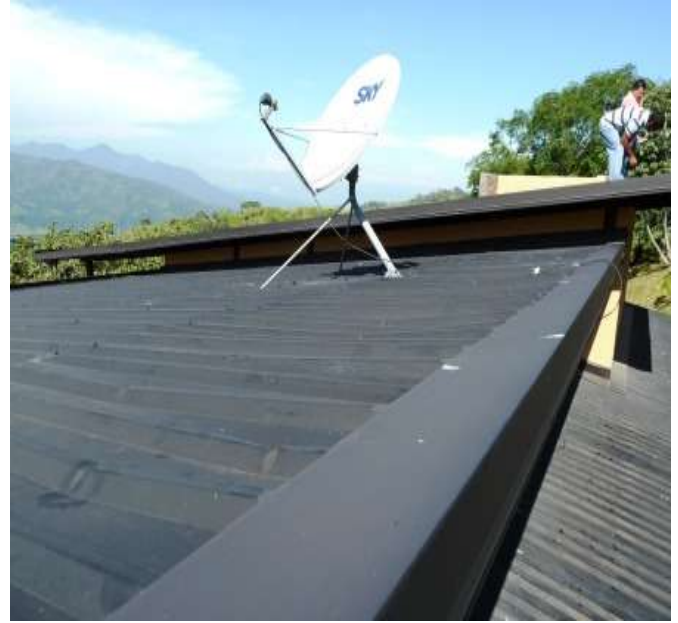
On the main residence, the roof laminates leaked during the water test in gaps at vertical joints where the laminates overlap and under the edge flashing where it sits on top of the laminates. The laminates have been dented by people standing on them and the best method to repair them is to remove the laminates and repair the dents or replace the laminates with new ones.

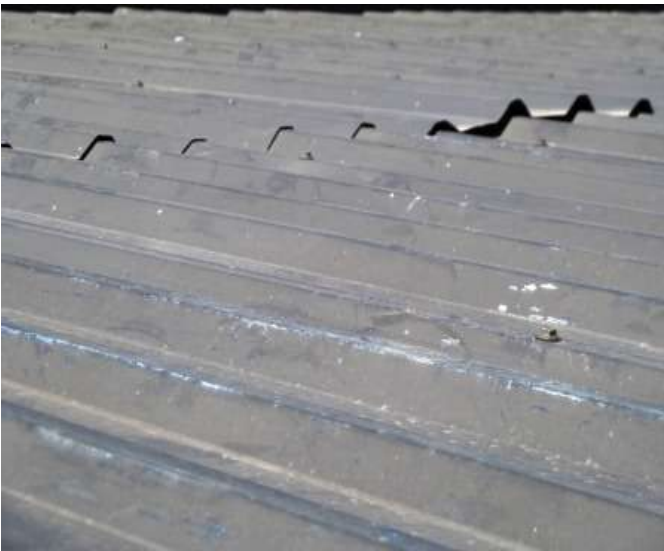
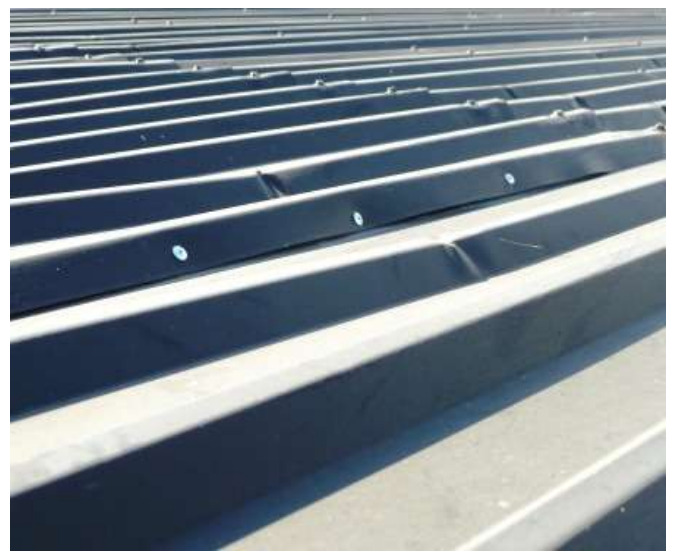
Additionally, on the main residence, the [thin gauge roofing laminates](#) have expanded and buckled up at the ends of the horizontal joints and driving rain can enter underneath. These laminates should be removed and replaced before applying a waterproofing product. In other areas of the roof on the main residence, [small stainless steel screws](#), commonly used to assemble lightweight metal structures, have been installed to close the gaps where laminates have buckled up. These screws are small, without any rubber washer and can unfasten themselves with slight movement of the laminates and then water can enter the holes.

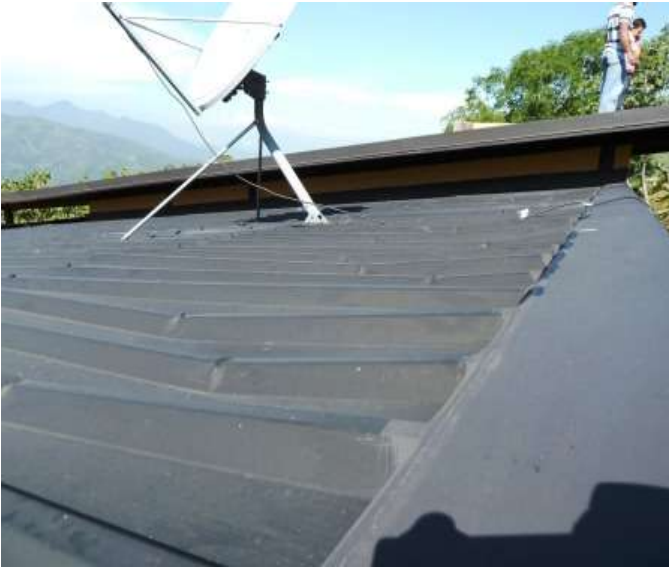
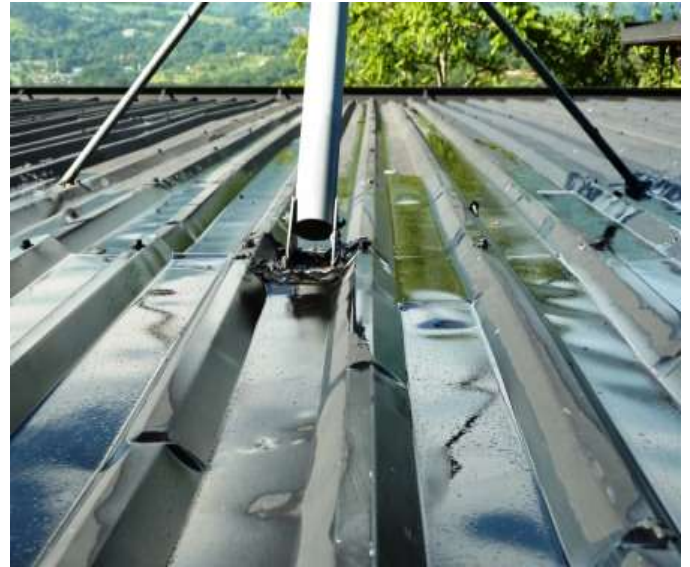
The television antenna installation was completed by amateurs and they damaged several roof laminates. There are irreversible dents as well as screw holes on the laminates where silicone sealant has been applied. The winds that blow at higher elevations in Costa Rica, like in Atenas, cause movement of roof mounted antennas and the screws become loose and penetrate the sealants, allowing water to enter. The damaged laminates should be removed and replaced prior to installing a new waterproofing product.

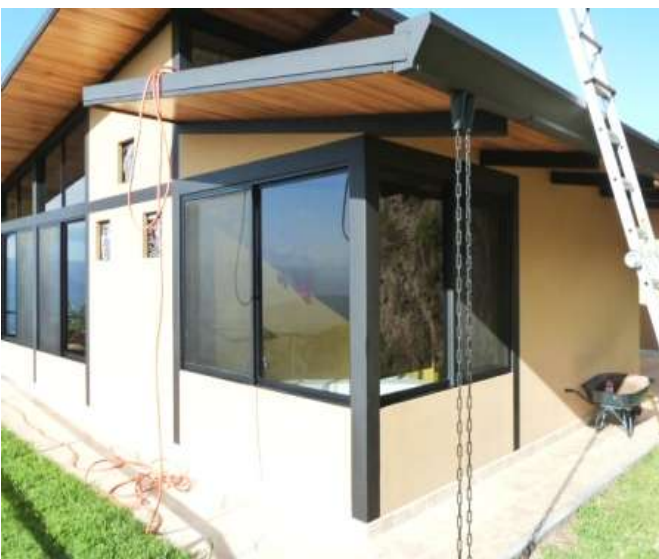
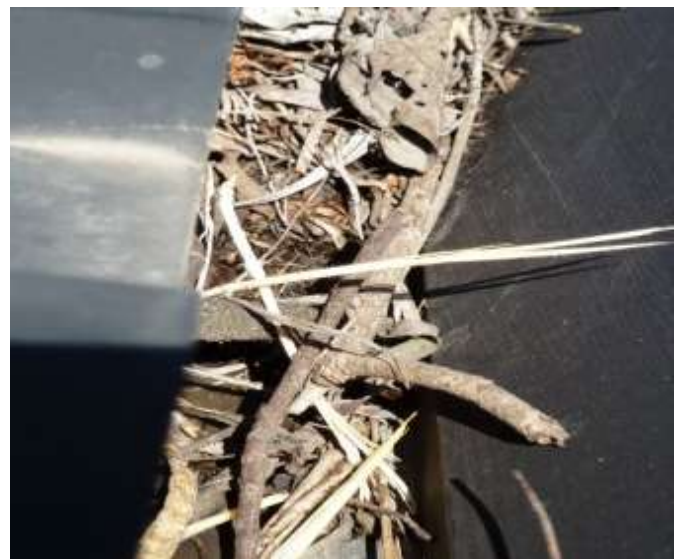
The gutters and downspouts are small and do not permit the rainwater to flow out of the gutters quickly enough to avoid the water backing up inside the gutters and flowing underneath the roof laminates and onto the fascia boards. There are watermarks on the underside the fascia boards which indicate this problem. Because the fascia boards are wood, they warp when exposed to extensive moisture. A flexible waterproofing membrane product can be installed on the surface of the laminates and then folded down into the back of the gutters to seal the gap between the bottom of the roof laminates and the back of the gutters, thereby preventing moisture from entering in the gaps.

Furthermore, some of the gutters are filled with debris near the downspout openings and they need to be cleaned in order to avoid further obstructions.
